CRASH INJURY INVESTIGATION

U. S. ARMY H-21C

SHAWNEE HELICOPTER ACCIDENT

Report of Crash Injury Investigation
AvCIR-11-PR-112
February 1960

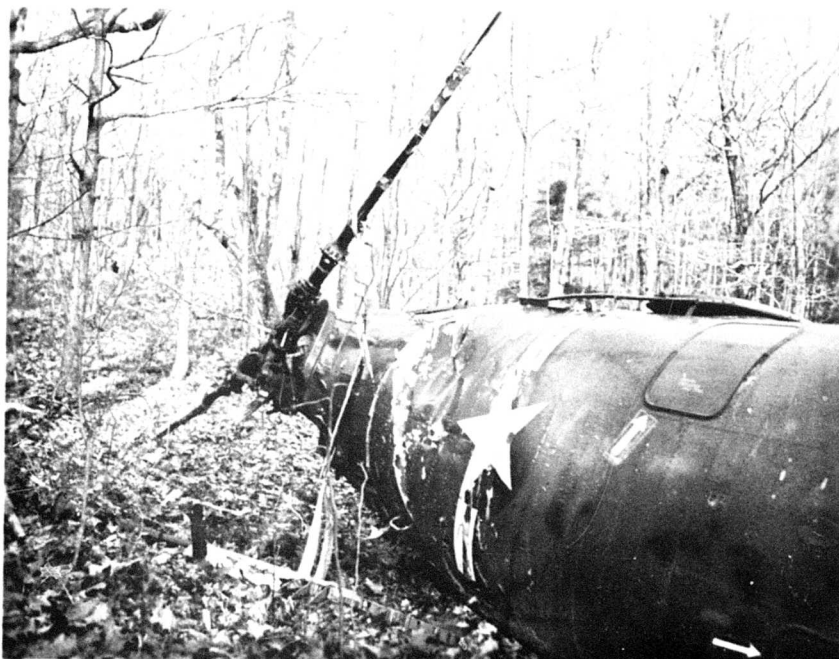
Although adequate emergency exits are provided in this aircraft, they were not utilized. Figures 9 and 10 show the location of two ceiling exits, which were operable but were not utilized, probably as a result of inadequate emergency evacuation briefing prior to the flight or the incapacitation of the crew chief.

↑ Figure 9. A view of the aircraft looking toward the forward rotor. The arrows indicate the operable, but unused, ceiling emergency exits.

The time required to evacuate all personnel from the aircraft including those requiring assistance indicates that more emphasis should be placed on briefing occupants of military aircraft on evacuation procedures and the location and use of emergency exits prior to the flight.

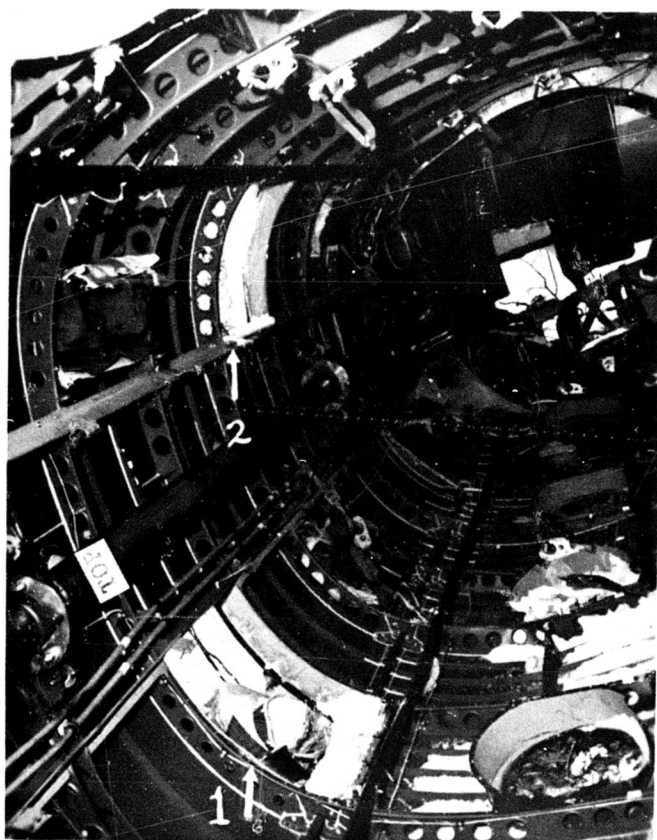
← Figure 10. Interior view of the operable but unused ceiling emergency exits (arrows 1 and 2). Both exits were opened by the accident investigators.

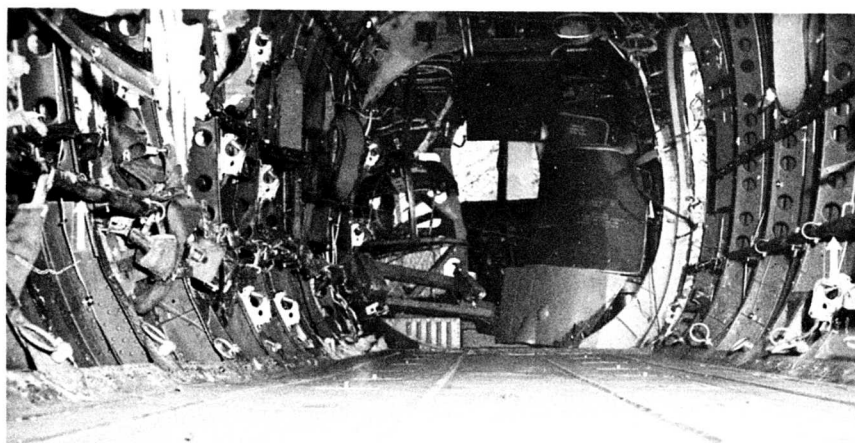
Figure 11. View looking forward to show intactness of the helicopter. The floor showed no distortion. Arrows denote the rear-seat supporting structure.

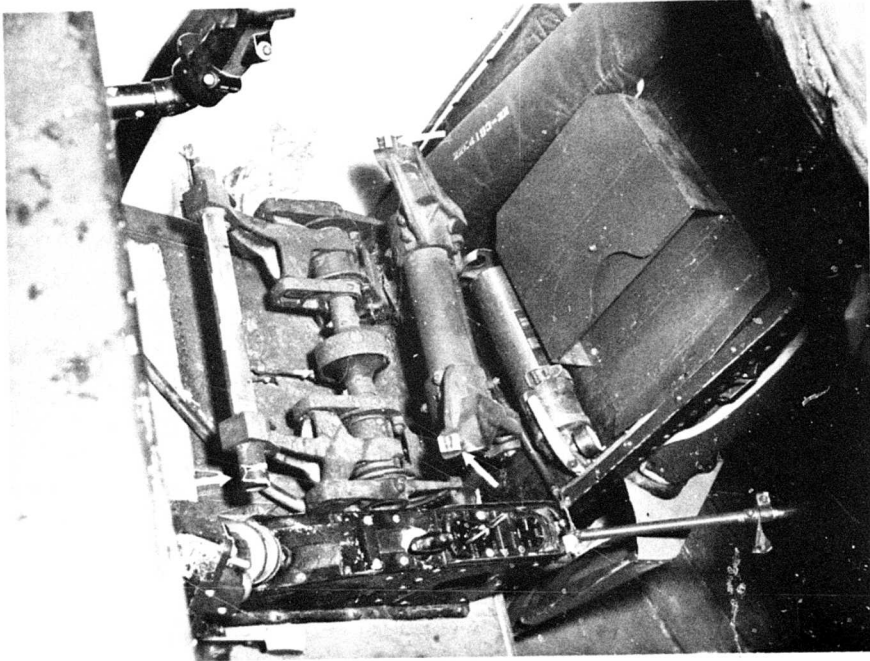
The most significant damage in the entire cockpit area was the failure of both pilot and copilot's seats during the lateral deceleration. Both seat supporting structures failed, permitting the pilot and the copilot to be thrown violently to the left. This movement caused the copilot to strike the left vertical support member, as shown in posed photograph (Figure 12). Figures 13 and 14 show the seat supporting structures and the failure points.

Figure 14. The four arrows in the photo depict points of failure of the seat support members on the pilot's seat. The failures are almost identical with those of the copilot's seat.

1. The seat supporting structure of the pilot and copilot seats in the H-21 be re-designed to prevent failures due to lateral forces under survivable conditions. A more ductile material, which will absorb energy through progressive collapse, is suggested.

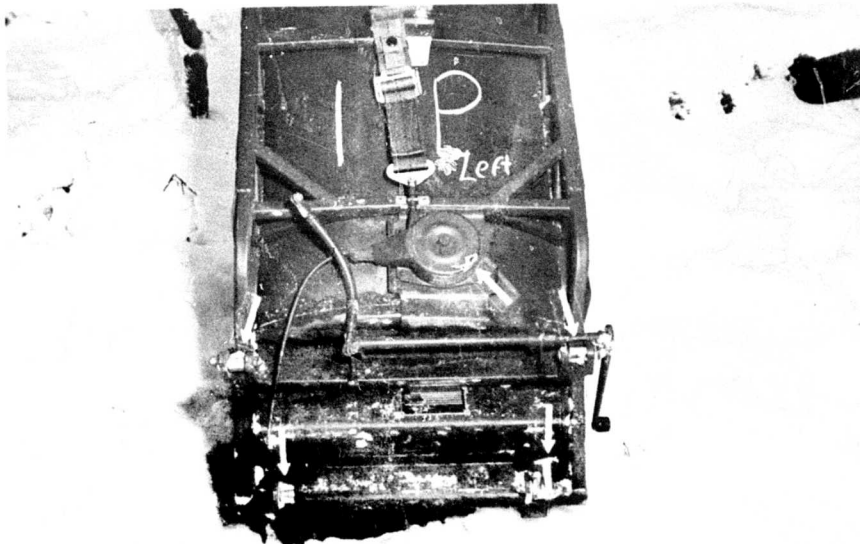
Figure 15. A rear view of the copilot's seat. Arrows depict points of failure of the support members. Location of inertia reel mounted on the seat back is also indicated.

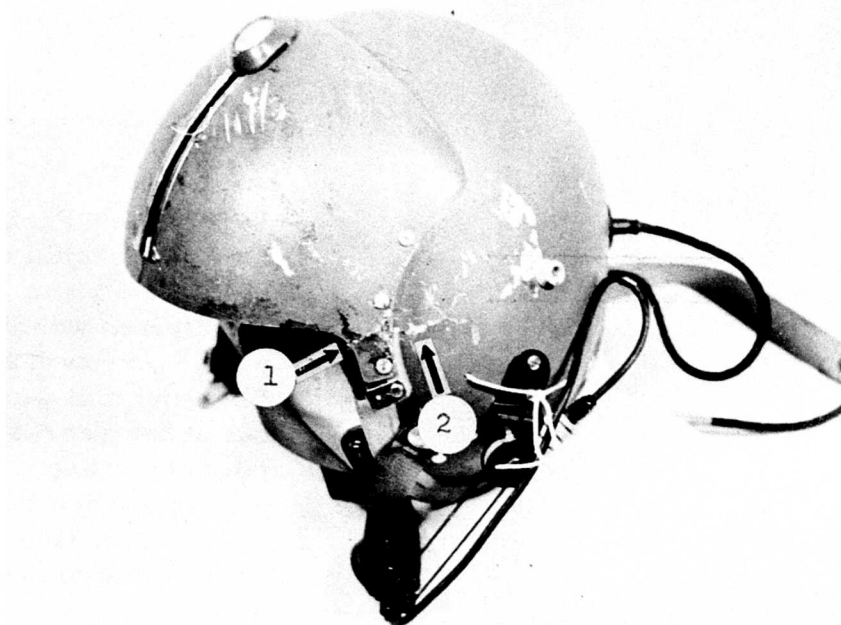
Figure 30. Impact marks were found on the left temple area and also on the visor housing. The arrows point out the area of impact.
